October 22, 2018

Candice Bigley
Project Manager
PMB | Advancing Healthcare Real Estate
3394 Carmel Mountain Road, Suite 200
San Diego, CA 92121

Subject: Arborist Report for the Soquel Avenue Property (APN 029-021-47), Santa Cruz, California

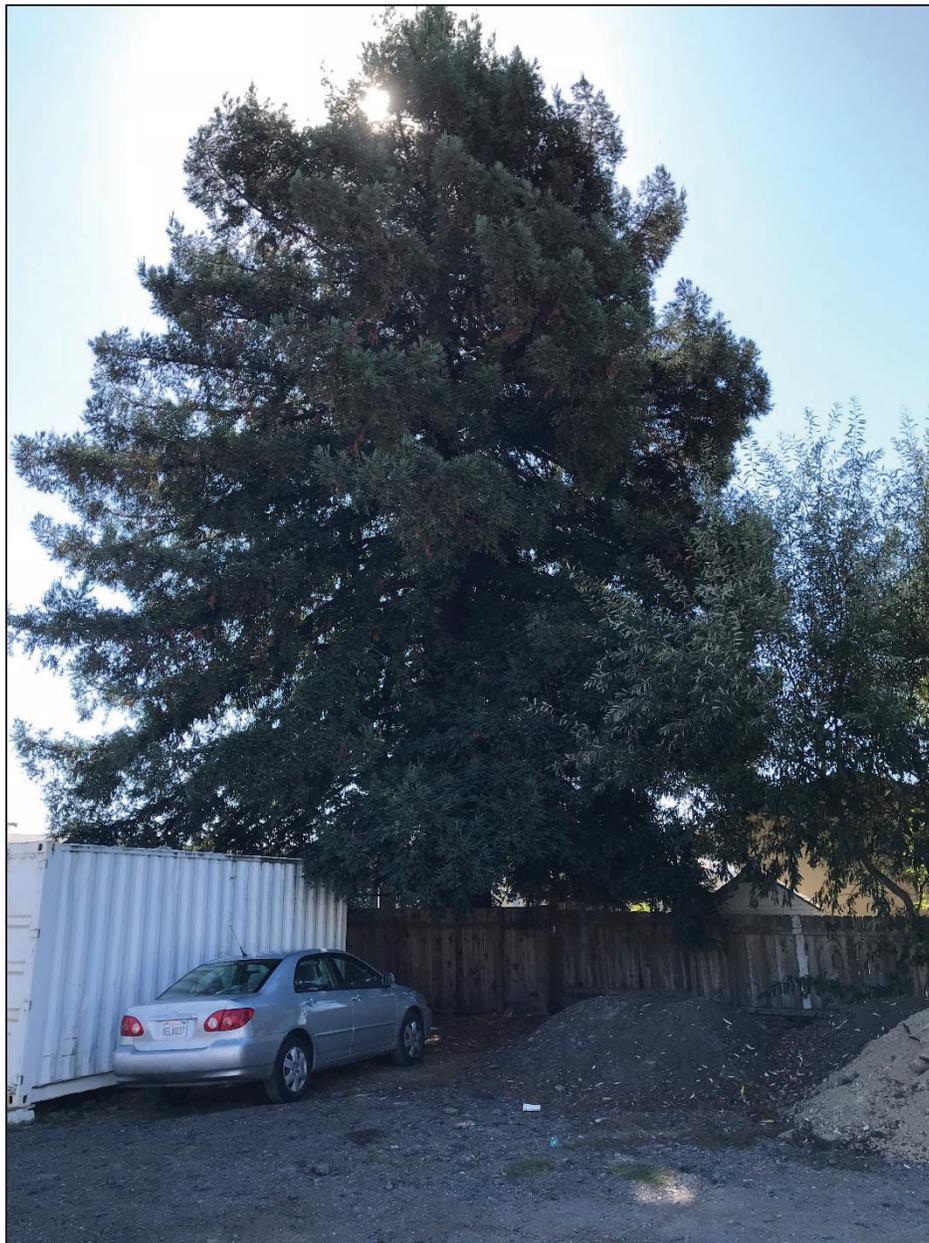
Photo 1: Tree #1 Coast redwood along southern property line.

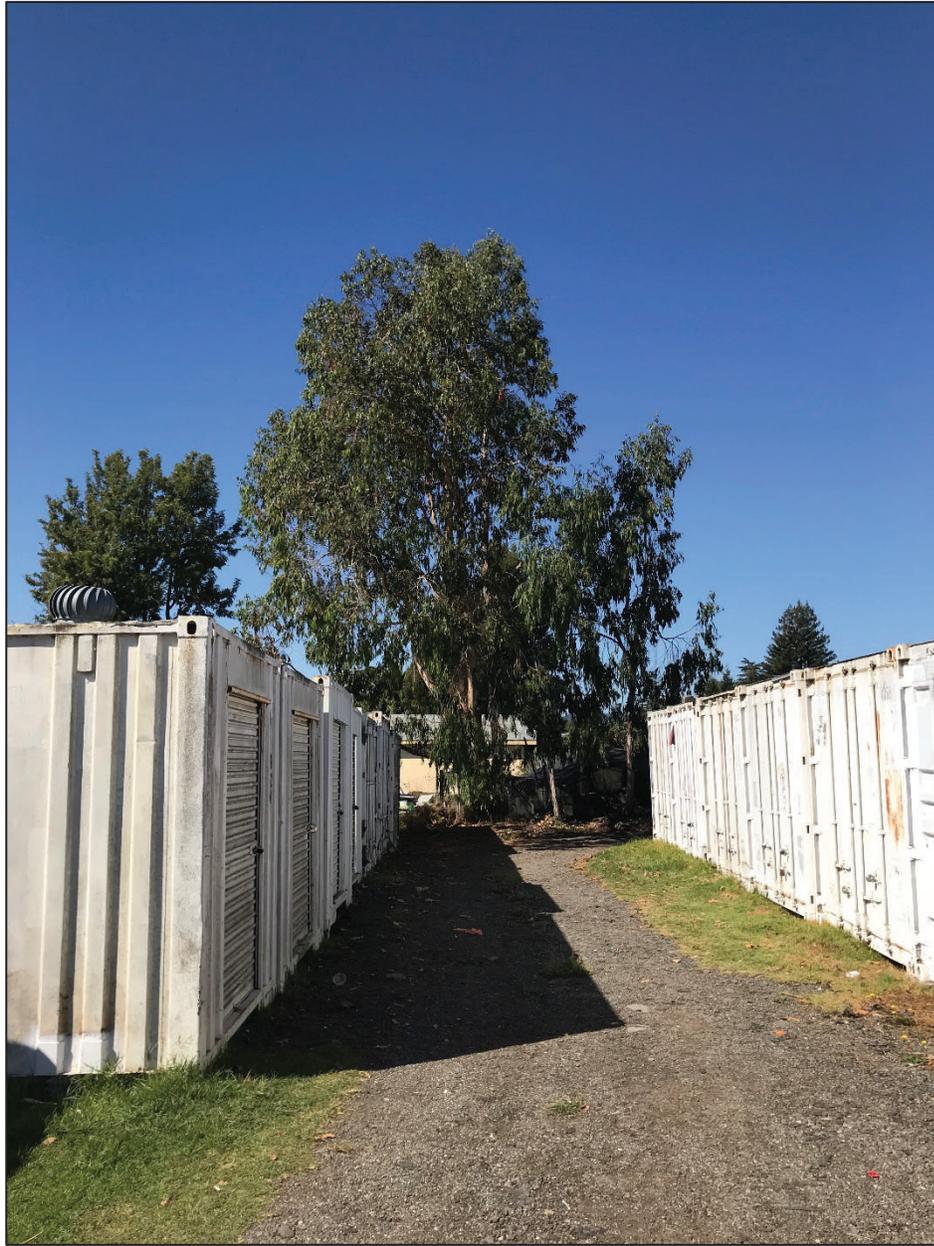
Photo 2: Trees #5-7 (left to right), blue gum trees along western property boundary line.

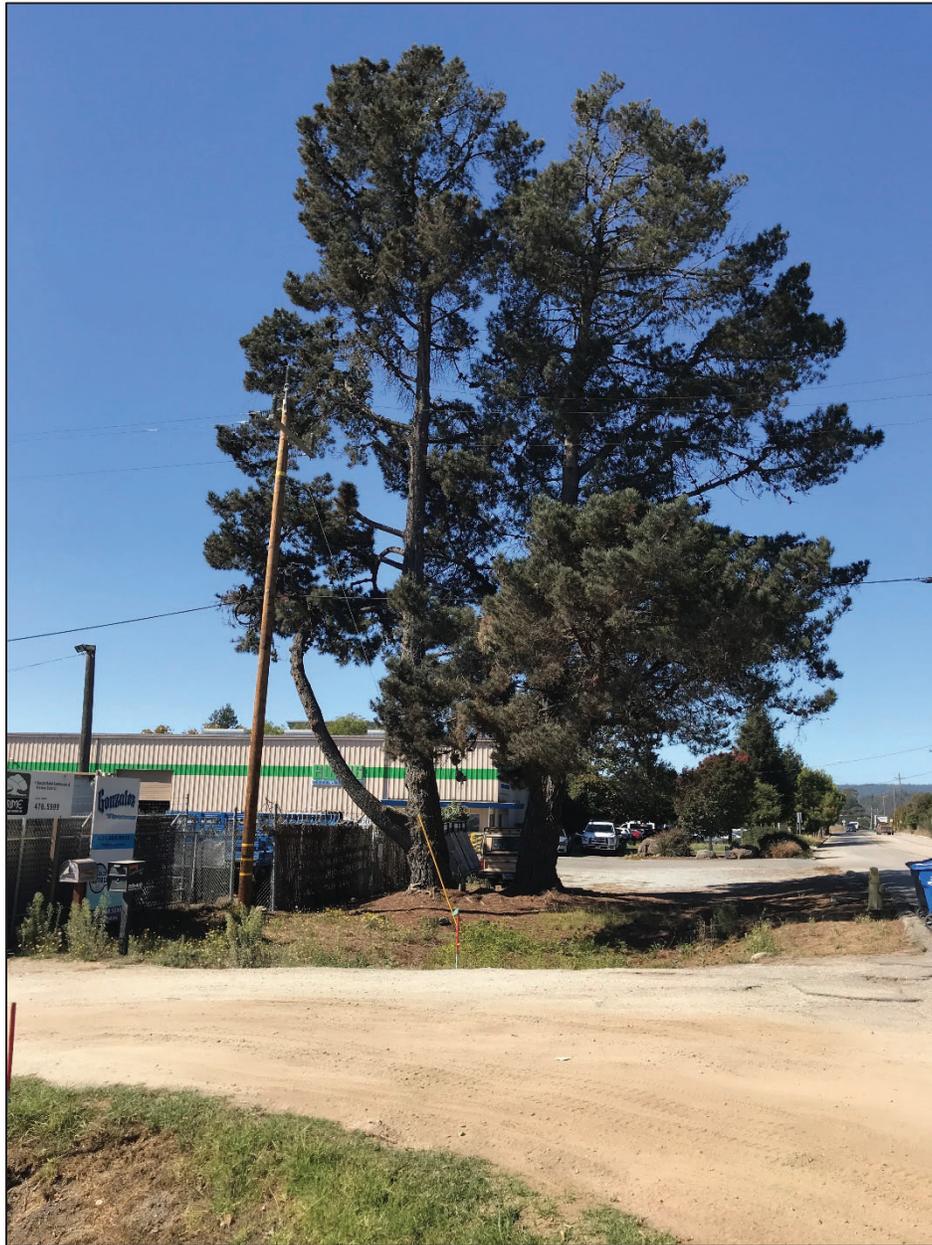
Photo 3: Trees #13-14 ,Monterey pines off-site, near property entrance.

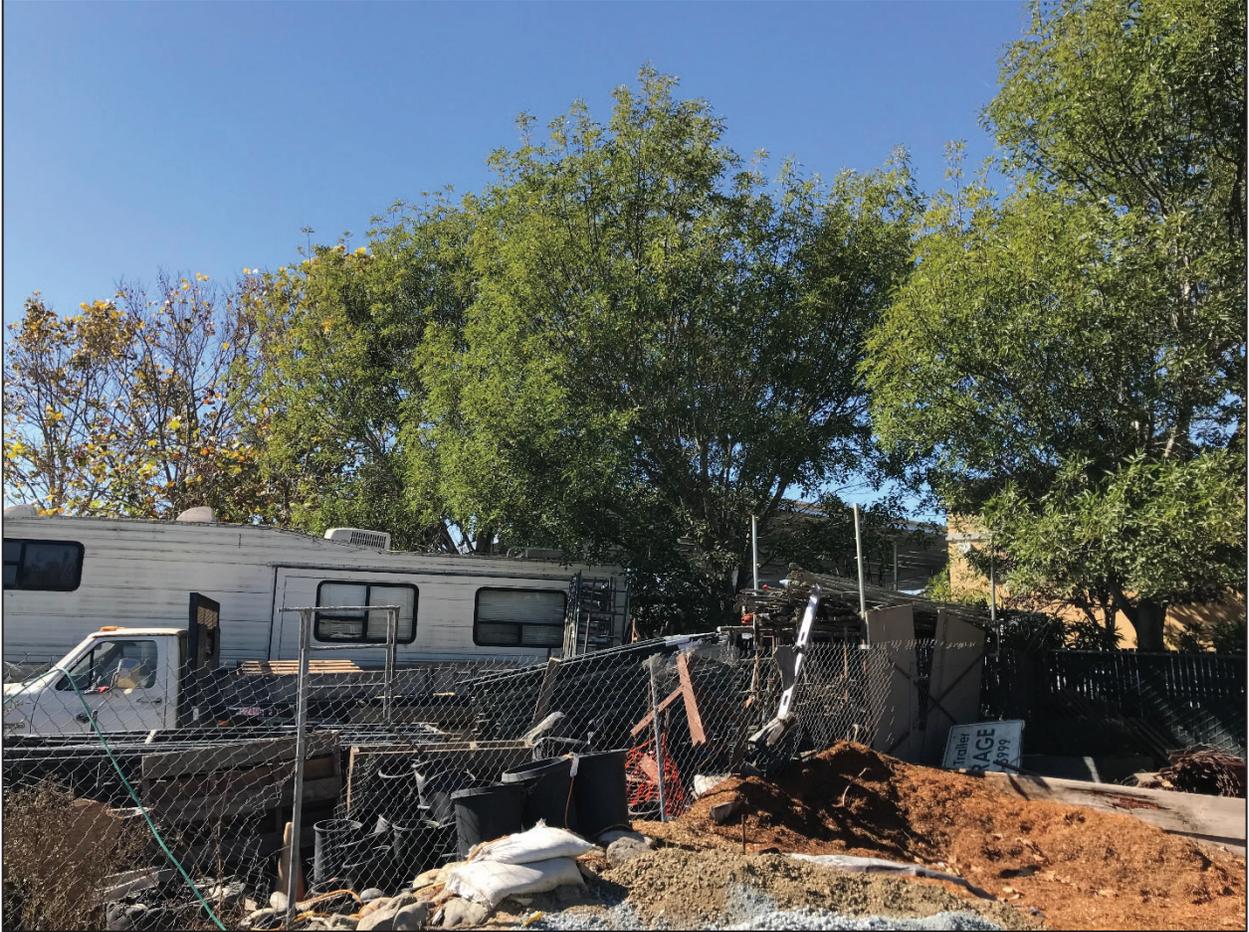
Photo 4: Trees #17-20 (left to right), non-regulated trees on adjacent property with canopies overhanging property line.
