PLANNING DEPARTMENT

NOTICE OF INTENT TO ADOPT A MITIGATED NEGATIVE DECLARATION

111078 SANTA CRUZ COUNTY CENTER FOR PUBLIC SAFETY

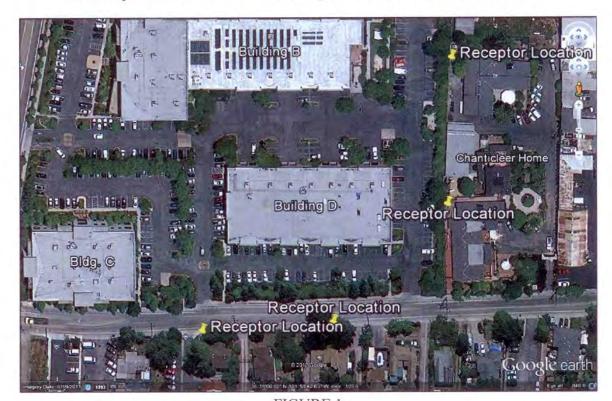
FIGURE 1

The residences most affected by the Building D equipment will be the residences of Chanticleer Home closest to Building D directly to the south and residences directly across Chanticleer Avenue to the west.

The receptor locations are shown on Figure 1, below. North is to the left.

Table I, below, provides the results of the noise level analysis. Shown in the Table are the total noise levels at each residential receptor location most impacted by the HVAC equipment associated with each of the three buildings.

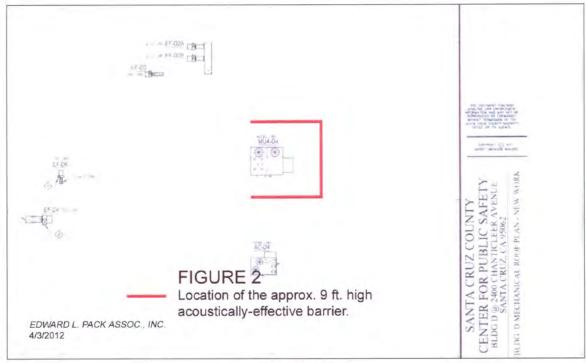
FIGURE 2

• Construct an acoustically-effective barrier around the east, south and west sides of MAU-4 on the roof of Building D. The top of the barrier shall be a minimum of 1 ft. above the top of the unit. The barrier will be approximately 9 ft. high, depending on the type of roof mounting system. A 1 ft. gap at the bottom of the barrier may be left for drainage. Please see Figure 2 on the following page. Initiate a compressor and fan lock out system for the condensing system on MAU-4 during the hours of 10:00 p.m. Saturday to 6:00 a.m. Sunday.

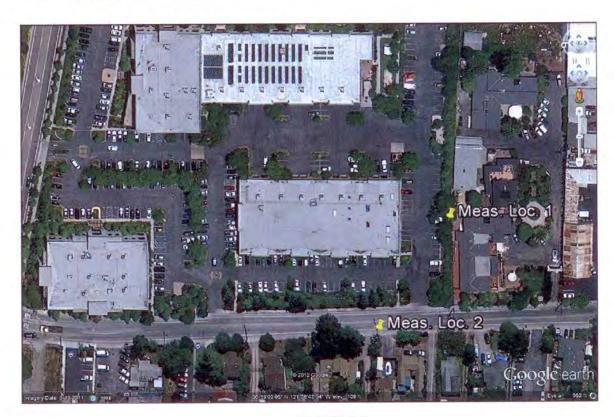
FIGURE 3

As the noise limits of the Santa Cruz County Noise Element have an adjustment factor to account for higher background noise environments, the existing ambient noise levels at the noise sensitive receptors were measured to determine if any adjustments to the noise limits are applicable. To determine the existing ambient noise levels, continuous recordings of the sound levels were made at two locations. Location 1 was along the southerly property line of the site near the rear corner of Building D contiguous with the Chanticleer Home. Location 2 was at the residential property line across Chanticleer Avenue directly across from Building D, farthest from Highway 1, where the background noise levels are lowest, hence, most restrictive. The measurement locations are provided on Figure 3, below.

The noise level measurements were made on March 9-12, 2012 for a continuous period of 57 hours at measurement Location 1 (until battery died) and for 72 hours at measurement Location 2. The noise levels were recorded and processed using Larson-Davis LDL 812 Precision Integrating Sound Level Meters. The meter yields, by direct readout, a series of descriptors of the sound levels versus time, as described in Appendix B. The measured descriptors included the L₁, L₁₀, L₅₀, and L₉₀ descriptors, i.e., those levels exceeded for 1%, 10%, 50%, and 90% of the time. Also measured were the minimum and maximum levels and the continuous equivalent-energy levels (L_{eq}). The measured L_{eq}'s are provided in the data tables in Appendix C and in the chart on page 9.

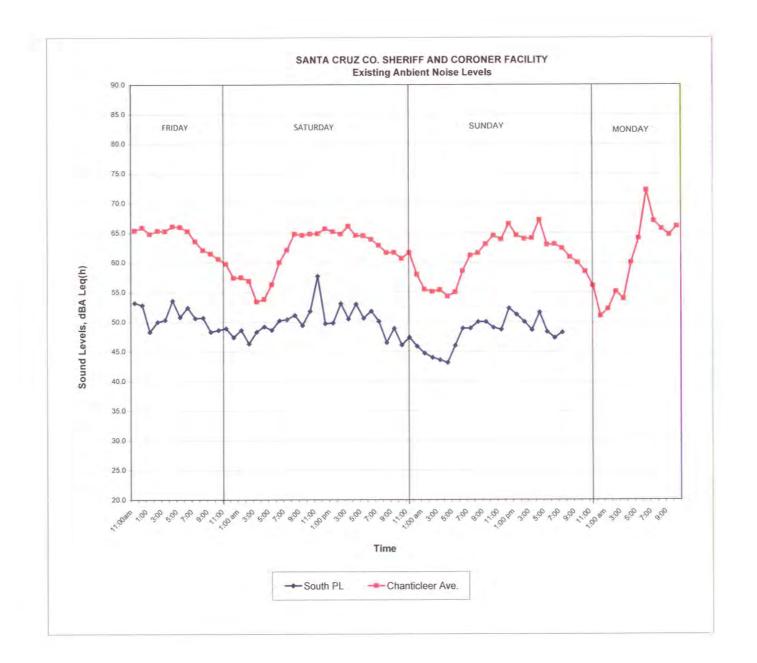
As shown in the Appendix C tables and on the chart, the L_{eq} 's at measurement Location 1, the Chanticleer Home property line adjacent to Building D, ranged from 46.5 to 57.7 during the daytime and from 43.6 to 50.2 dBA at night. The lowest daytime L_{eq} was 46.5 dBA. The lowest nighttime L_{eq} was 43.6 dBA. As both the lowest daytime and lowest nighttime noise levels are below the standard noise limit of the Noise Element, no adjustments to the noise limits are applicable.

The L_{eq} 's at measurement Location 2, the property line of the residence along Chanticleer Avenue property line across from Building D, ranged from 60.0 to 67.0 dBA during the daytime and from 51.0 to 72.2 dBA at night. The lowest daytime L_{eq} was 60.0 dBA. The lowest nighttime L_{eq} was 51.0 dBA. As both the lowest daytime and lowest nighttime noise levels are higher than the standard noise limit of the Noise Element, the noise limits are adjusted up to the lowest ambient level during the daytime and nighttime periods, respectively.
