Atkinson Lane Specific Plan and PUD

Draft Environmental Impact Report

Volume II: Technical Appendices

Atkinson Lane Specific Plan and PUD Technical Appendices Volume II

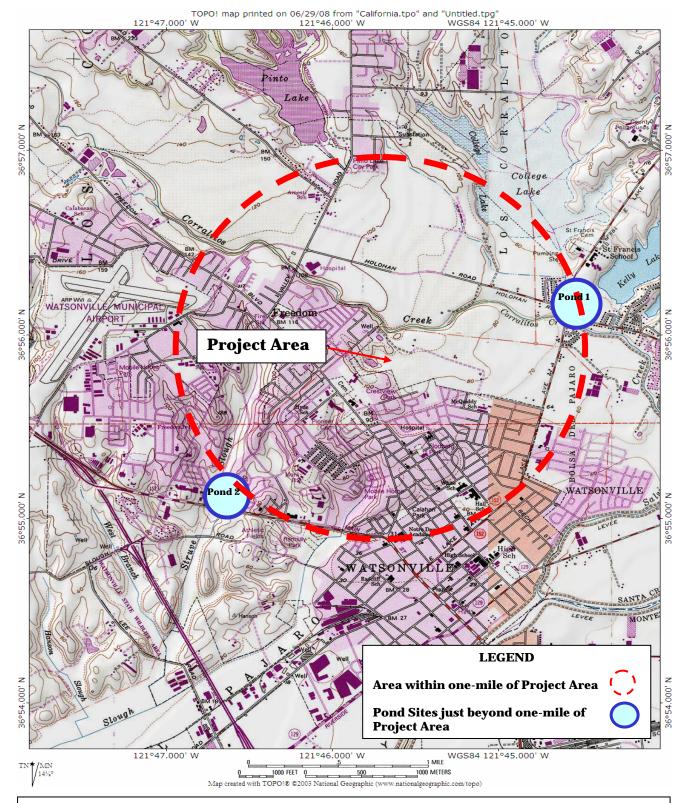
Figure 3. Locations of pond sites just beyond one mile of the proposed City of Watsonville Atkinson Lane Specific/Master Plan Area, Santa Cruz County,

Pond 2 is to the southwest and is within an arm of Struve Slough (Figure 3). This pond appears to serve as a run-off detention basin for the surrounding subdivisions. The pond margins support mostly freshwater marsh vegetation, but a dense stand of willows is present at the tail end. No water was present in the pond on 6 June.

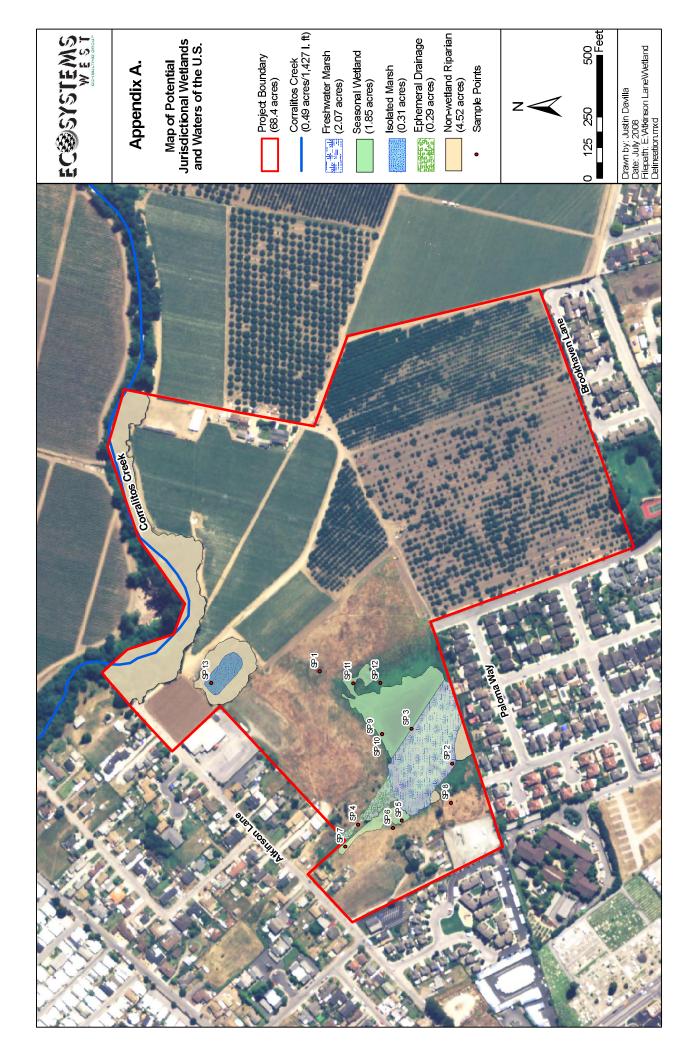
Appendix A. Map of Potential Jurisd	lictional Wetlands and Waters of the U.S

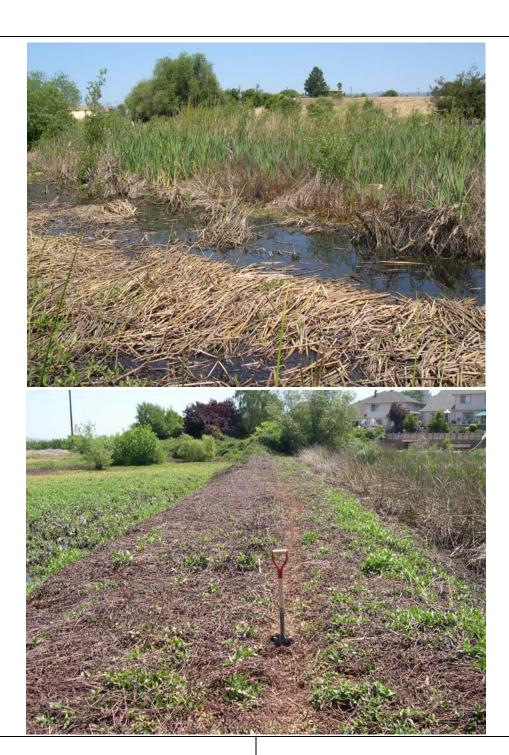
Top. Potentially jurisdictional freshwater marsh in north-central portion of the Project Area.

Bottom. Sample point of levee berm separating freshwater marsh from seasonal wetland.

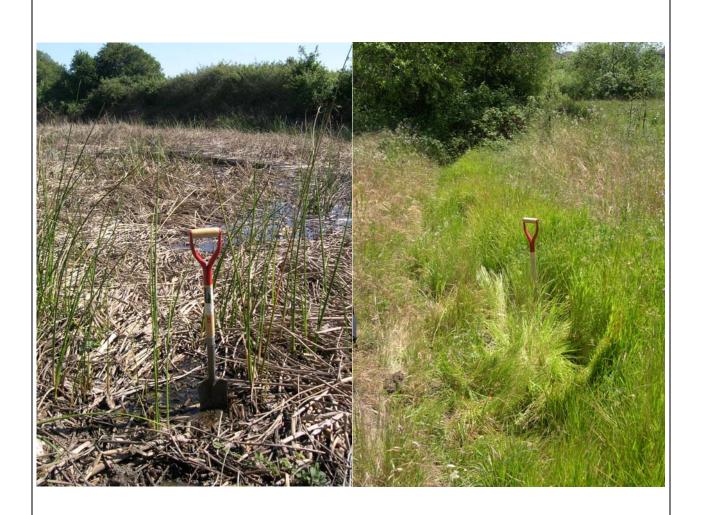
Left. Sample point 13 in potentially isolated detention basin in northwest of property.

Right. Sample point 4 dominated by Italian ryegrass in ephemeral drainage/swale.

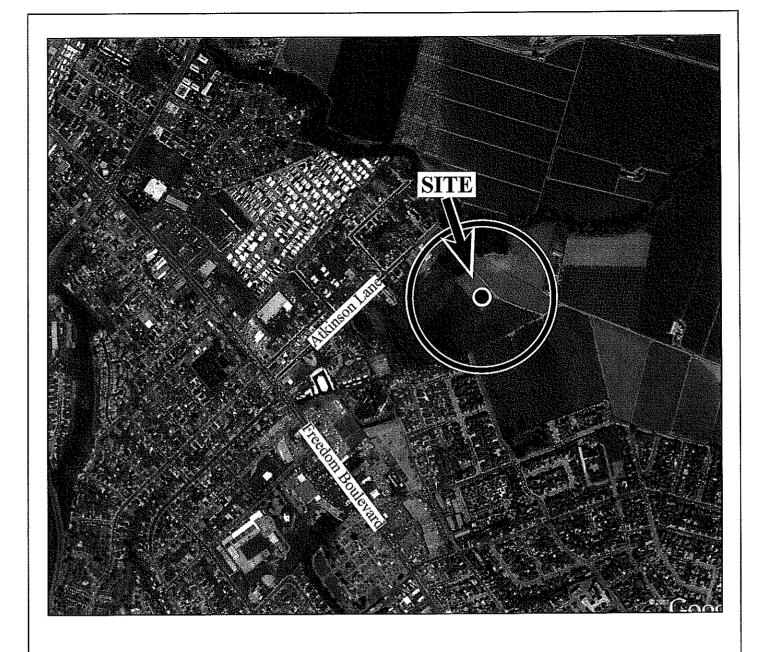
Figure No. 1 Project No. 0829 Date: 3/2/09

Regional Site Map Atkinson Lane Development Watsonville, California Base Map from Google Maps

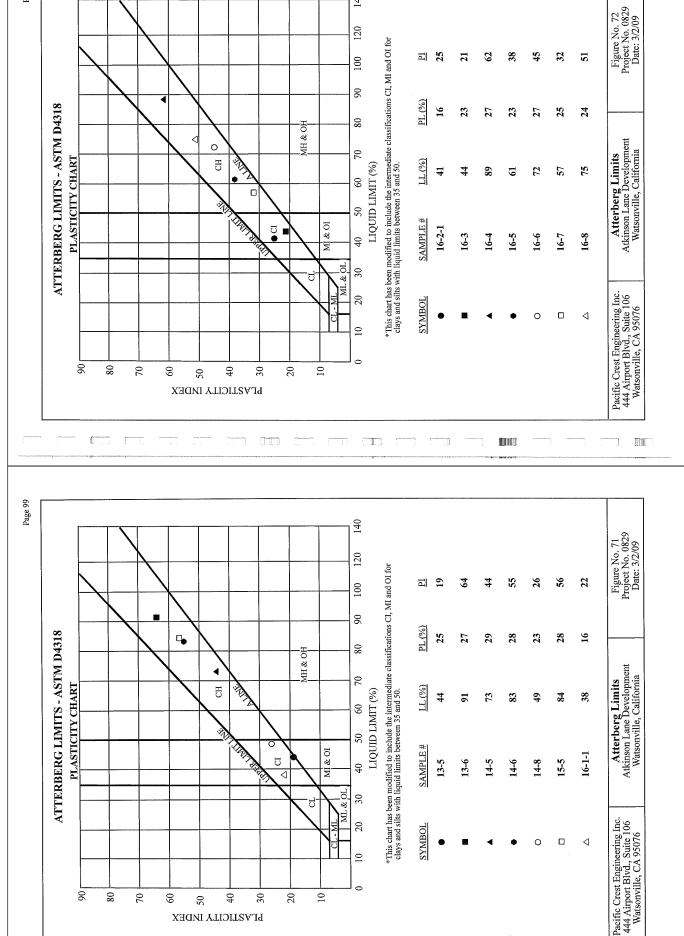
20	- In					0 90 100	<u>II</u>	36	39	53	38	20	44	52	17	Figure No. 73 Project No. 0829 Date: 3/2/09
FM D4318	<u>-</u>			MH & OH		70 80 lassifications C	PL (%)	25	25	27	17	24	76	26	25	nt
MITS - AST	PLASTICITY CHART		# • ·			40 50 60 LIQUID LIMIT (%) include the intermediate c	55 and 50. LL (%)	61	64	80	22	44	70	78	42	Atterberg Limits Atkinson Lane Development Watsonville, California
ATTERBERG LIMITS - ASTM D4318	PLASTIC			5 00	MI & OL	30 modified to	n nquia nimits between .	16-9	16-10	16-11	18-2-1	18-5	18-6	19-5-1	19-6	Atterbe Atkinson Lan Watsonvill
A1		09 05 X	EGUTY TUDE:		10 CTN	0 10 20 **This chart has been	ctays and silts will SYMBOL	•	•	4	•	0		◁	0	Pacific Crest Engineering Inc. 444 Airport Blvd., Suite 106 Watsonville, CA 95076

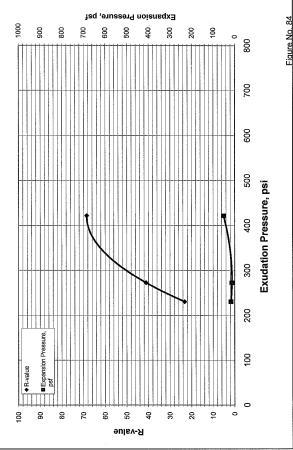
roject No. 0829 Date: 3/2/09

Date: 06/02/08 Initial Moisture, 8.6%	Inc. Tested MD R-value by Fn	Reduced RU Stabilometer	Checked DC Expansion 20 not	Pressure 20	A B C D Remarks:	273 422 231	1200 1200 1200	46 30 59	3132 3134 3220	2067 2081 2109	2.44 2.44 2.6	12.8 11.3 13.9	117.2 117.4 113.5	12.9 51.6 17.2		72 32 112	4.1 4.34 3.84	
Ď		æ	 	(Silty)									ľ			72 32		
Job No.: 416-343	Client: Pacific Crest Engineering, Inc.	Project: Atkinson Lane - 0829	Sample R2 from B-1	Soil Type: Grayish Brown Clayey SAND (Silty)	Specimen Number	Exudation Pressure, psi	Prepared Weight, grams	Final Water Added, grams/cc	Weight of Soil & Mold, grams	Weight of Mold, grams	Height After Compaction, in.	Moisture Content, %	Dry Density, pcf	Expansion Pressure, psf	Stabilometer @ 1000	Stabilometer @ 2000	Turns Displacement

R-value Test Report (caltrans 301)

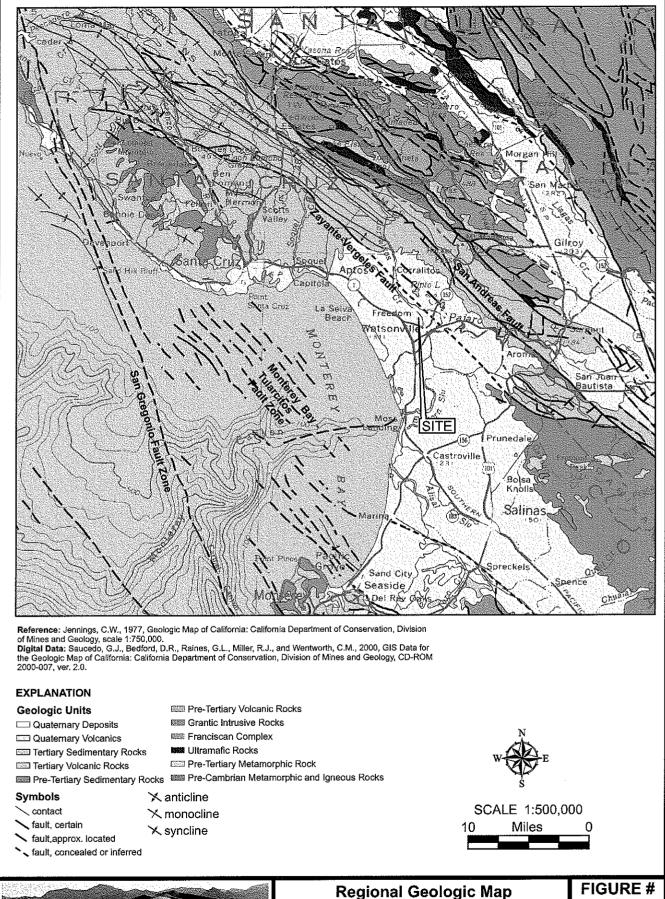
Regional Geologic Map Atkinson Lane EIR Atkinson Lane Watsonville, California FIGURE # 2 JOB # 2008010-G-SC

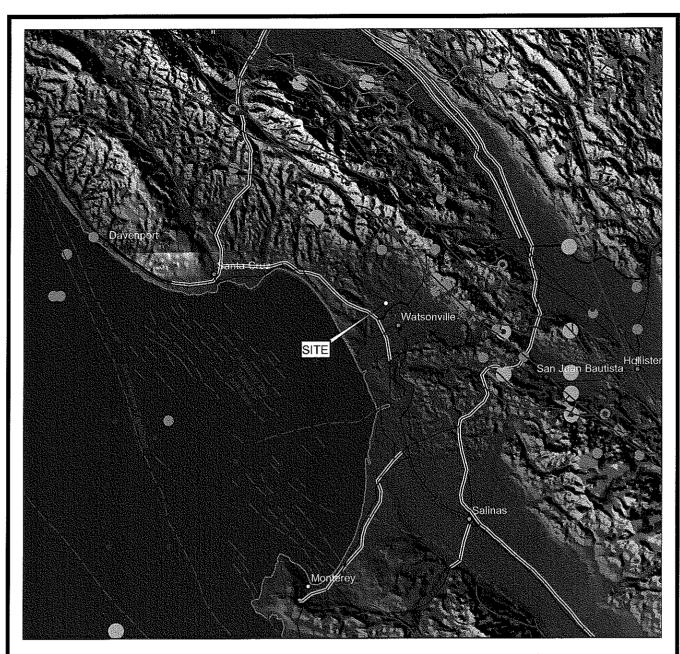
Seismicity Information: Magnitude 4 and greater earthquakes, compiled from various sources, 1769 to 2000; available at www.consrv.cagov/CGS/rghm/quakes/cgs2000_fnl.txt Fault Information: Jennings, C.W., 1977, Geologic map of California: California Department of Conservation, Division of Mines and Geology, scale 1:750,000

Regional Seismicity Map Atkinson Lane EIR Atkinson Lane Watsonville, California FIGURE # 3 JOB # 2008010-G-SC

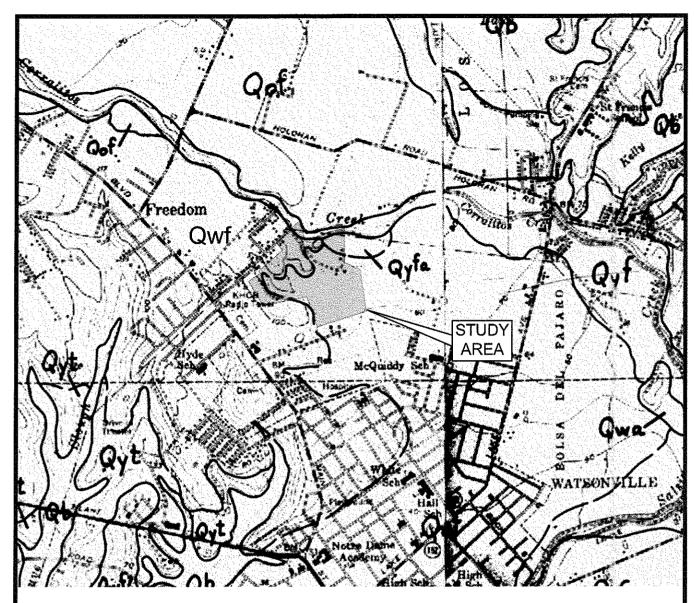
FIGURE# JOB# 2008010-G-SC

BASE MAP: "MAPS SHOWING GEOLOGY AND LIQUEFACTION POTENTIAL OF NORTHERN MONTEREY AND SOUTHERN SANTA CRUZ COUNTIES, CALIFORNIA", Dupre and Tinsley, 1980, Sheet 1 of 2, Scale 1:62,500, U.S. Geological Survey Miscellaneous Field Studies Map MF-1199.

Local Geologic Index Map Atkinson Lane EIR Atkinson Lane Watsonville, California

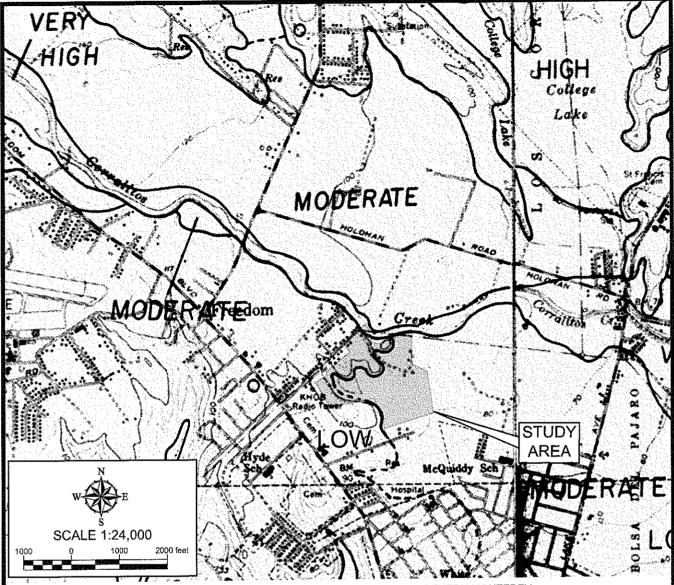
BASE MAP: "MAPS SHOWING GEOLOGY AND LIQUEFACTION POTENTIAL OF NORTHERN MONTEREY AND SOUTHERN SANTA CRUZ COUNTIES, CALIFORNIA", Dupre and Tinsley, 1980, Sheet 2 of 2, Scale 1:62,500, U.S. Geological Survey Miscellaneous Field Studies Map MF-1199.

ZONES OF LIQUEFACTION SUSCEPTIBILITY
